WEEKLY STATUS REPORT

| BCP Project No.: | C224099 | EPA Consent Order No.: | CERCLA-02-2017-2021 | Date: | 09/02/2019 |
| Project Name: | BRT Powerhouse 153 2 nd Street AKA 322 3 rd Avenue, Brooklyn, NY 11215 | | | | |

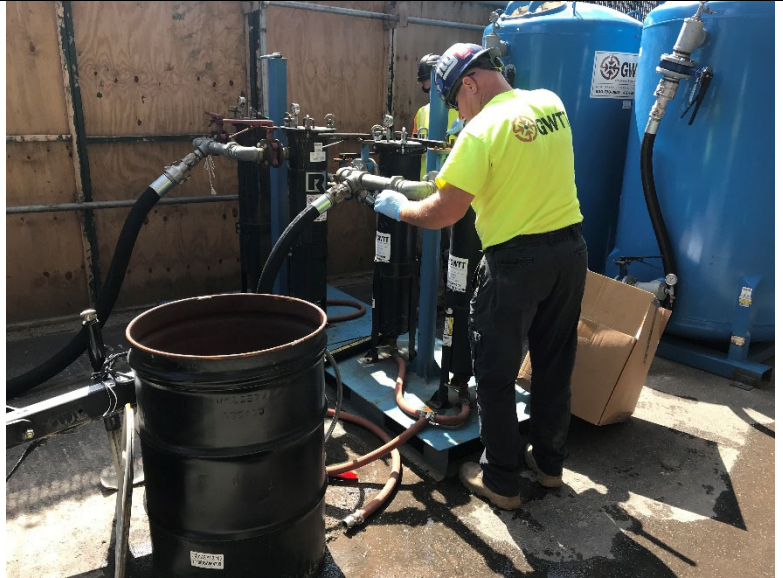
Photo 1 – Looking southeast at the groundwater treatment system. Structure Tech and Ground/Water Treatment and Technologies make modifications to the treatment system.

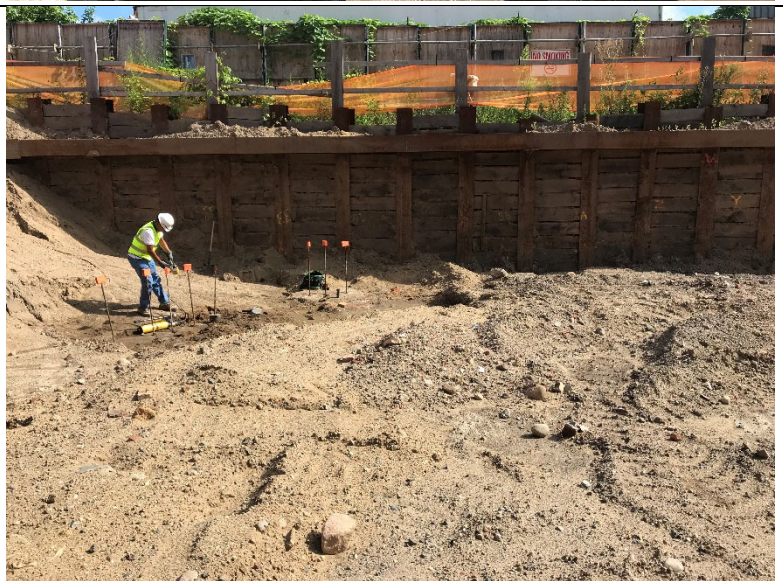
Photo 2 – Looking north at the boiler house slab. Atlantic Engineering Laboratories continues pull-tests at the boiler house slab.

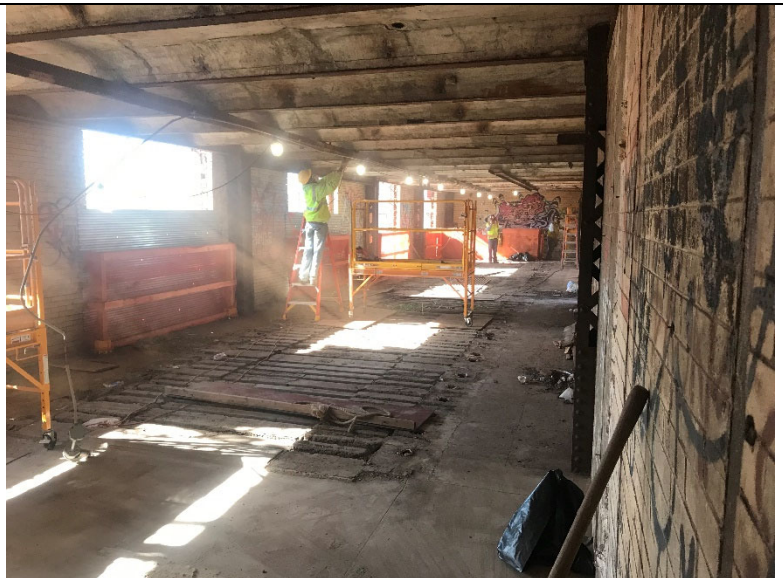
Photo 3 – Looking south in the turbine hall. US Spray continues scraping steel on the fourth floor of the turbine hall.
